Office Products

CE Technical Operations Amsterdam

April 18, 1980

TO: All GBG & OP Customer Engineers GBG/I, WT E/ME/A, WT A/FE
SUBJECT: Customer Engineering Memorandums (CEMs) 7/8/9XX Typewriter

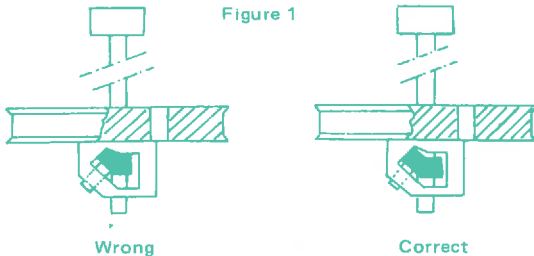
Figure 1

1. That key, rotate pulley (code 702 Ref. 422) is not pressed against pulley before tighten ball socket shaft (look at figure 1). Change key code 702-Ref. 422).

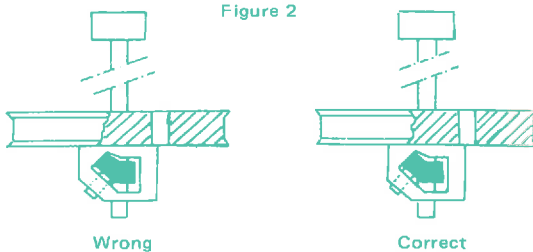
Figure 2

2. If setscrew in rotate pulley is tighten against lower ball socket shaft (look at figure 2). Change rotate pulley code 402 Ref. 420.

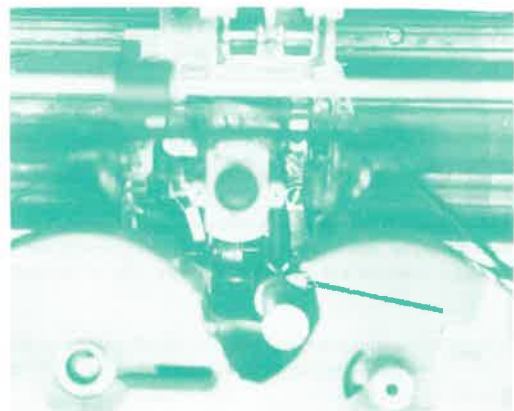
Intermittent print failures & spiked driven gear (715-57) wearing can be caused by interference between spiked driven gear & tilt spring bracket (702-328). Above failures only occur when impression control lever is in position 5 & used ribbon on take up core moves spiked driver in front of tilt spring bracket (look at figure).

If you have this problem loosen mounting screw & move tilt spring bracket to rear. If this is not enough clearance, form tilt spring bracket.

NOTE: Hold rotate spring retainer (702-426) in position when you loosen tilt spring bracket mounting screw to prevent unload of rotate spring tension.

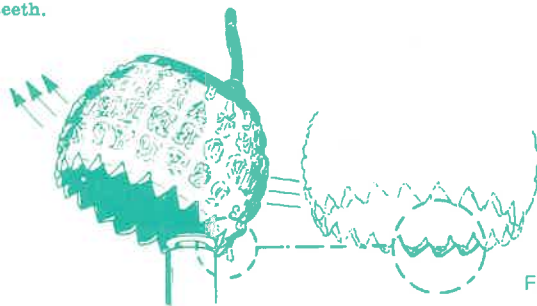
Figure 1

SYMPTOM: Broken teeth in the area of +5L.C and -5U.C position can be caused by not fully detenting the typehead lever (02-182) before the typehead is lifted off the tilt ring.

SOLUTION: Typehead lever has to be complete detented in open position before head is lifted off upper ball socket. If not it is possible that lever spring rotates head against upper ball socket causing broken teeth.

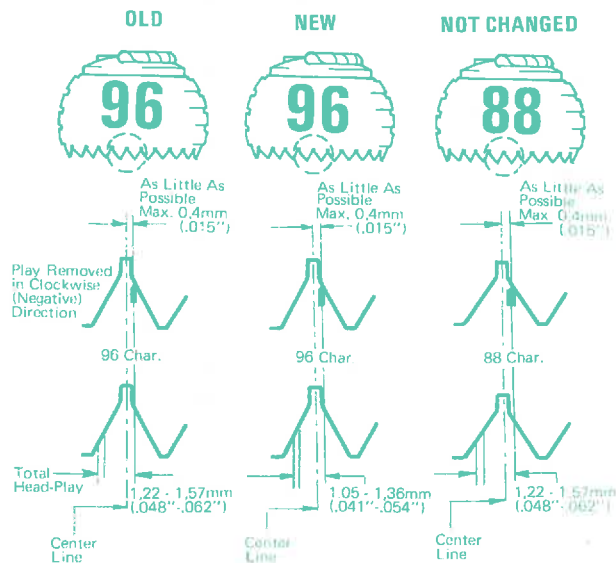
Detent Pos. And Play Viewed From The Rear Of Machine
(Figure 1)

The head play should be 1.22 mm — 1.57 mm for 8XX and 1.05 mm — 1.36 mm for 9XX with the correct ball joints installed. The distance between teeth on a 88 character typehead is approximately 3.8 mm and on a 96 character typehead 3.4 mm. If discovering too much or too little head play, inspect pins in upper and lower ball socket and ball joint. Replace wrong parts.

P/N 8169890 upper ball socket insert 8XX.
P/N 8169107 upper ball socket 9XX.
P/N 1124220 Ball joint 8XX.
P/N 1449893 Ball joint 9XX.
P/N 1164550 Lower ball socket.

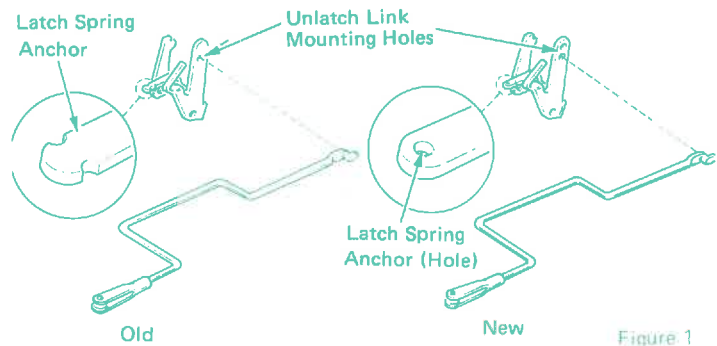
Figure 1

PURPOSE: Two additional holes have been added to the carrier return latch (03-207). One is an additional hole for the carrier return unlatching link (03-202) and the other is a hole to anchor the latch spring (03-205) (Figure 1).

SOLUTION: Replace the latch (03-207) and reconnect the unlatching link (03-202) in the lower hole and attach the latch spring to the hole in the anchor lug.

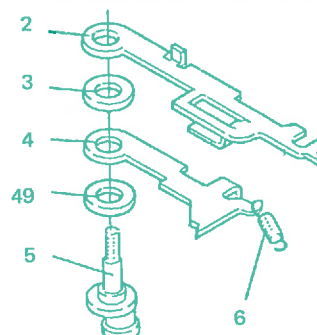
PURPOSE: To reduce lost motion when the pawl is activated.

SOLUTION: Add spacer (07-49) to escapement bracket. This spacer should be added between the pawl and the stud (see Figure 1).

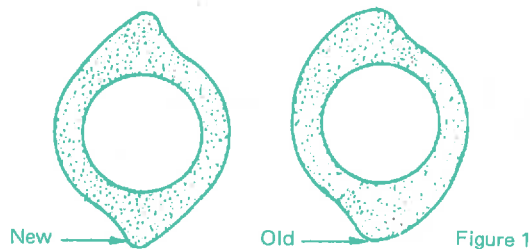
Figure 1

- a) Check the level of escapement cam.
Change to new level if necessary. To recognize the new part look at the contour of the high point, it is sharper (See Figure 1).

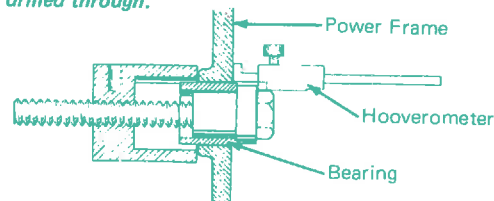
1. Type head detenting keeps changing.
2. Motor speed is changing.
3. —5 Latch adjustment keeps changing.
4. Impression is different.
5. Smearing.
6. Noise.

Check for worn center bearing.

1. With type head installed, hand cycle-5character (Selection latches have to load under ball) until rotate detent is under head tooth, & remove head play.
2. Push down cycle clutch pulley. If movement of head is 1 mm (.040") or more, center bearing is worn.

Note: Before changing center bearing, be certain that play is in center bearing & not only between cycle shaft & pulley hub.

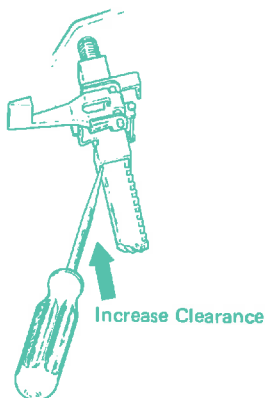
Binding margins on 7/8/9XX typewriters can be caused by the machine being too low in the covers. When experiencing this problem, raise the machine so there is a slight clearance between the margin slider and the chrome strip on the center cover.

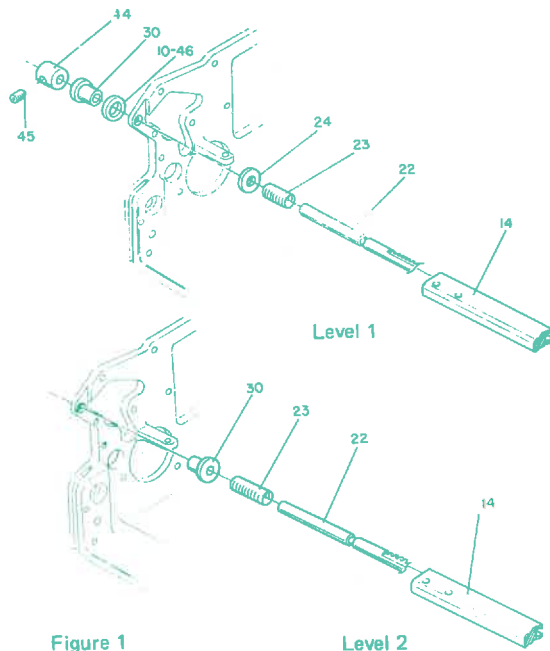
Two spacers (10-46, 24), a collar (10-44) and a setscrew (10-45) have been eliminated from the single pitch margin rack. This has been done by using a shorter spring (10-23) and installing the collar (10-30) from the opposite direction.

It is no longer necessary to use these parts (10-24, 44, 45, 46). If replacement of these obsoleted parts is necessary, the new shorter spring (10-23) should be used and the parts assembled as in Figure 1 (Level 2).

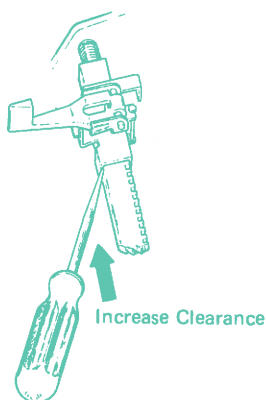
Binding margins on 7/8/9XX typewriters can be caused by the machine being too low in the covers. When experiencing this problem, raise the machine so there is a slight clearance between the margin slider and the chrome strip on the center cover.

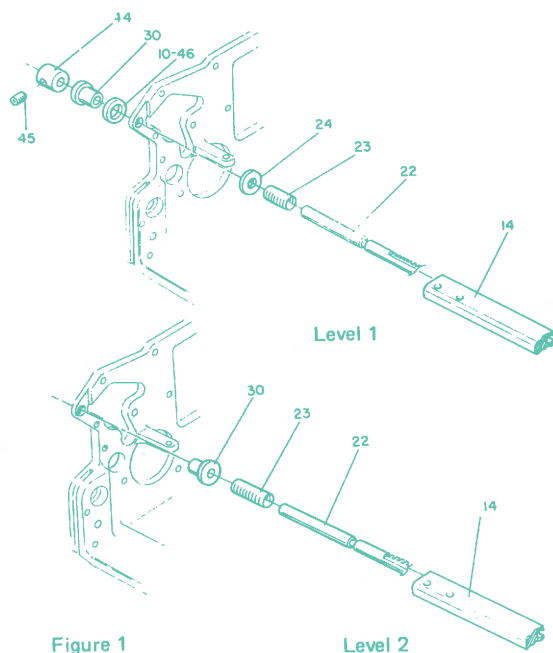
Two spacers (10-46, 24), a collar (10-44) and a setscrew (10-45) have been eliminated from the single pitch margin rack. This has been done by using a shorter spring (10-23) and installing the collar (10-30) from the opposite direction.

It is no longer necessary to use these parts (10-24, 44, 45, 46). If replacement of these obsoleted parts is necessary, the new shorter spring (10-23) should be used and the parts assembled as in Figure 1 (Level 2).

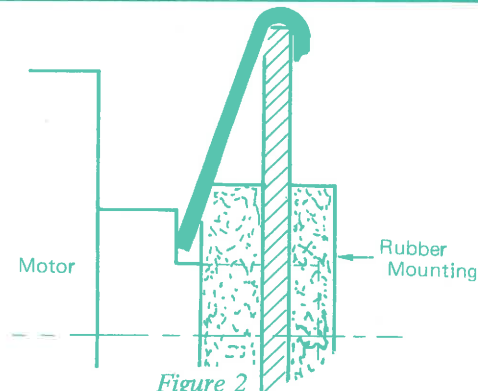
Figure 2

Note: Make certain that vertical lug of Static Elimination Bracket touches motor frame and is installed between rubber motor mounting (11-106) and motor frame (see figure 2). In case of painted motor frame remove the paint. Check with meter for continuity.

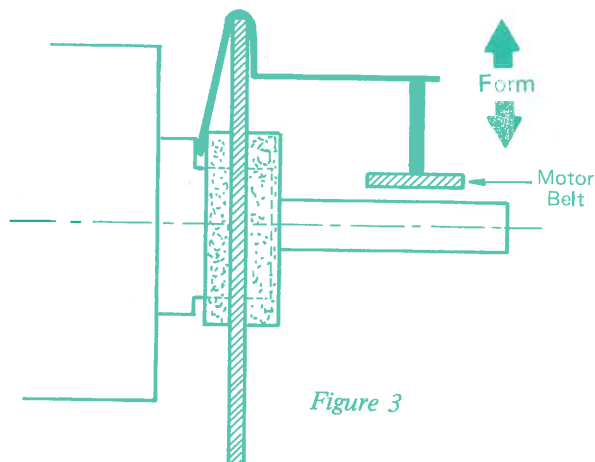
Figure 3

- 4) Re-assemble plastic motor guard (11-103).
- 5) Place motor package into machine.
- 6) Adjust motor pulley according to frame 9 (APM-241-5939) if necessary.
- 7) Center Static Elimination Follower in the middle of motor belt, by forming horizontal lug of Static Elimination Bracket (see figure 3).

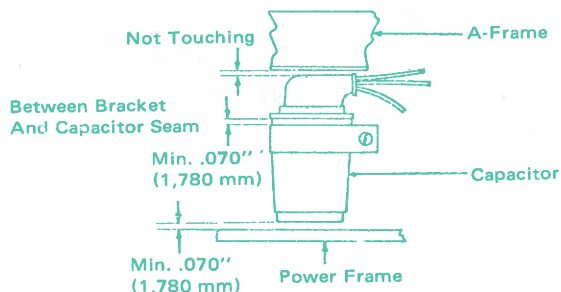
It is possible that some machines A-Frame paper feed, capacitor is positioned too high contacted with lower part of A-Frame.

Note: When replacing line cord, switch or motor on old level machines, reposition capacitor as shown in drawing. On next service call of inspection check capacitor is correctly positioned.

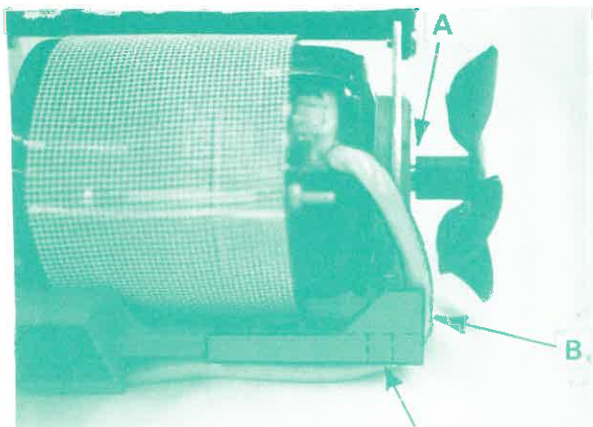
The outside motor fan (730-400) in WT 8XX machines with Sound Reduction Package can contact motor cable and make wires blank.

Plant will change motor unit and make hole in bottom to fit cable.

On installation check all 8XX with Sound Reduction Package & without hole in bottom of plastic bracket.

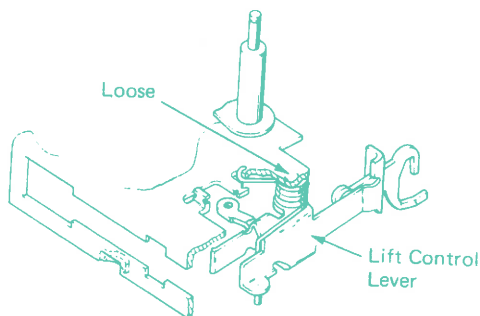
Lift Control Lever Mounting Stud - Loose

In case of intermittent ribbon lift failures with selective ribbon mechanism, check mounting stud of lift control lever, (715-76). If loose, change ribbon plate assembly (715-151) P/N 6519998 or (726-20) P/N 1206023.

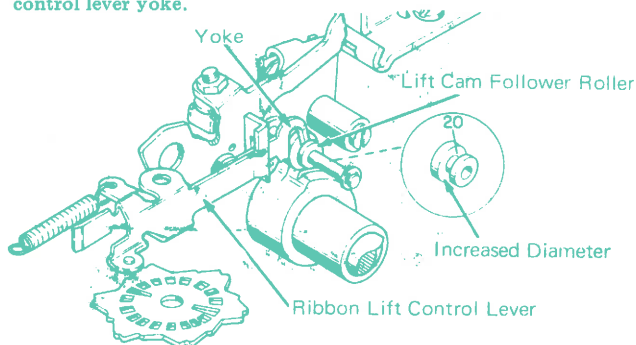
Diameter of follower increased to prevent it from slipping out of control lever yoke.

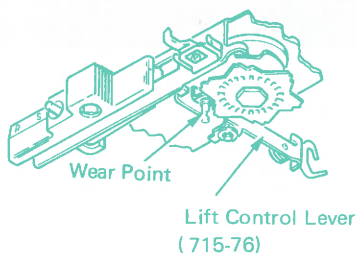
If selec. or correct. Ribbon Lift Mech. gives intermittent failures, check lift control lever stud (715-76) for wear. Replace lift control lever if necessary.

Note: Stud can be easily checked with machine in stencil position.

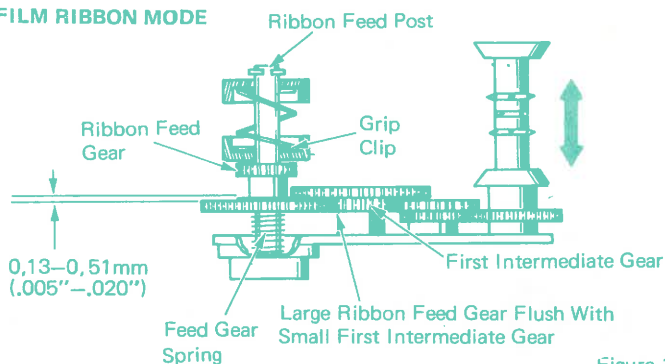
Figure 1

When replacing feed gear (715-92) & intermediate gear (715-55) due to wear of the teeth, make certain ribbon mode button grip clip is adjusted up or down on ribbon feed post for 0.13–0.51 mm (.005"–.020") clearance between lower feed gear and first intermediate gear (with mechanism in film ribbon mode). Bottom of large ribbon feed gear should be flush with bottom of small intermediate gear.

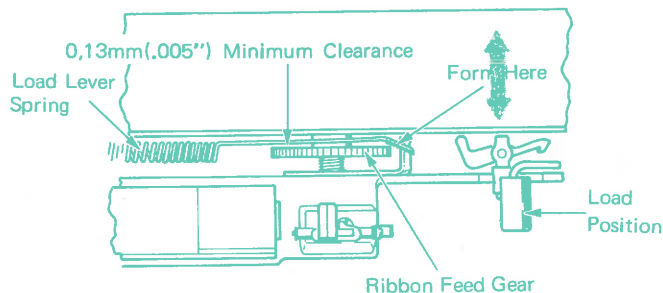
Figure 2

- Make sure load lever spring clears ribbon feed gear with minimum of 0.13mm (.005") in ribbon load position. Form load lever spring.

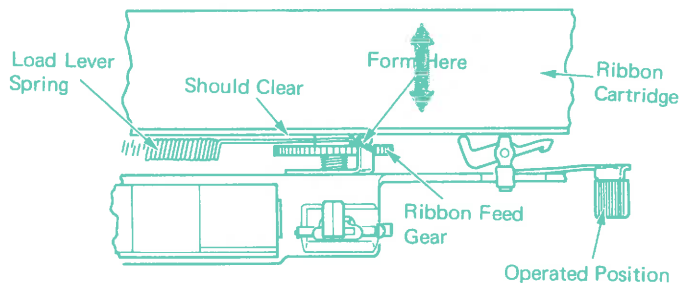
Figure 3

- Make sure load lever spring clears ribbon cartridge in operated position. Form load lever spring if needed.

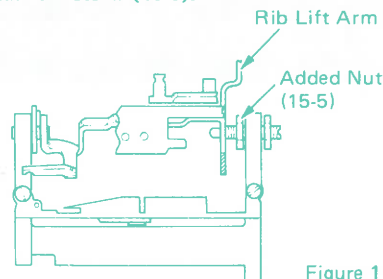
Figure 1

PURPOSE: If the mounting screw hole for the ribbon lift arm is damaged, an additional nut (15-5) can be added to the inside of the carrier to retain the screw (15-6).

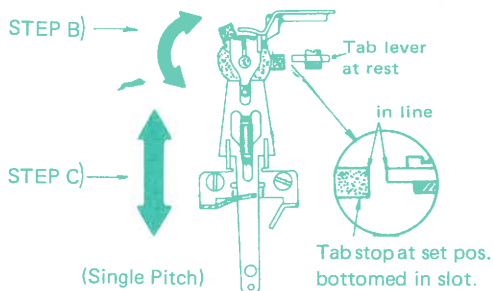
SYMPTOM: Tab stops cleared after repeated tab operations.

- Manually set a tab stop until it is bottomed in the slot of the rack.
- Loosen tab rack screw (18-44) and rotate tab rack radially until the top surface of the tab stop is in line with the top surface of tab lever pawl (see figure).
- Form tab set lug up or down to ensure that the tab stops are bottomed in their slots when the tab set button is operated.

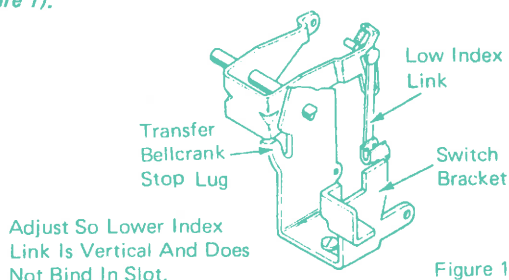
Figure 1

Note: Make sure the link does not bind in the transfer bellcrank slot (Figure 1).

If clip breaks, replace with new C-clip, P/N 1290995.

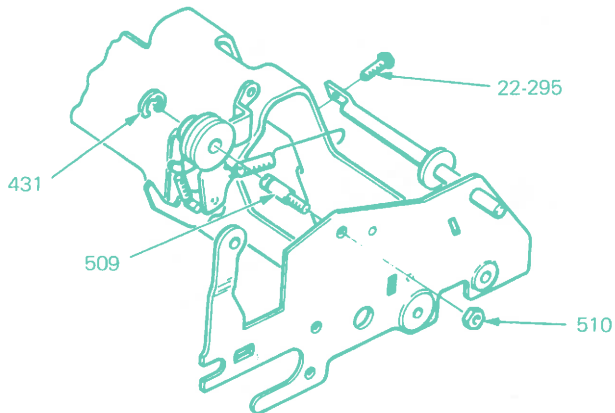
SYMPTOM: Index pawl assembly stud loose or broken.

Tap the hole of the paper frame (22-49 or 266) with a 4-40 tap or a self-tapping screw such as the one on the index selector lever mounting stud (22-295). Install the stud (20-509) and nut (20-510).

It may be necessary to form the platen latch to the right to remove interference between the nut and latch. Reinstall pawl assembly and "C" clip (20-431).

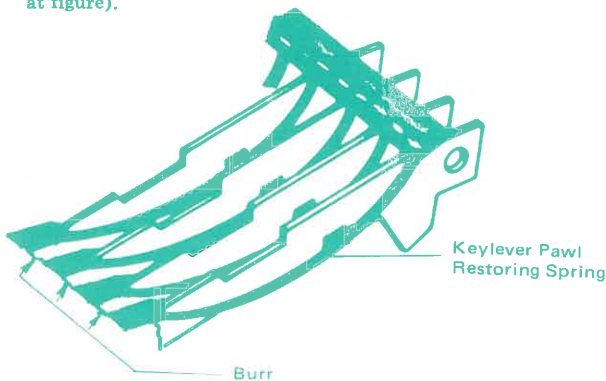
Check keylever restoring spring (721-42) for burrs between spring tips if you have problems to get keylever pawl at rest after operation (look at figure).

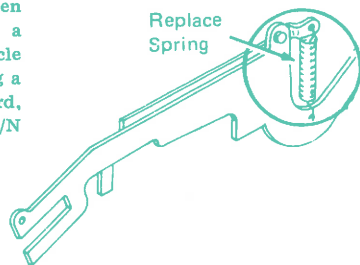
Some machines may have been shipped to the field with a heavy spring on the cycle clutch latch. If experiencing a "heavy" or "tight" keyboard, replace this spring with P/N 1123827.

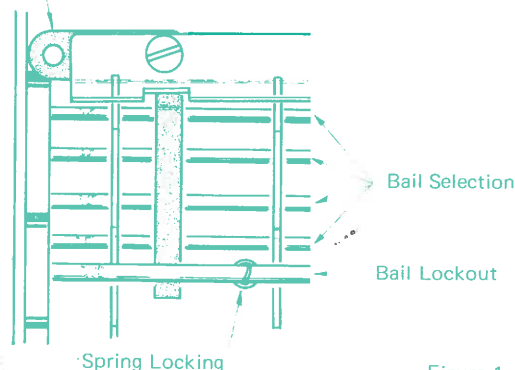
Figure 1

SOLUTION: The damper spring is mounted now near the L.H. Keyboard side plate (See Figure 1).

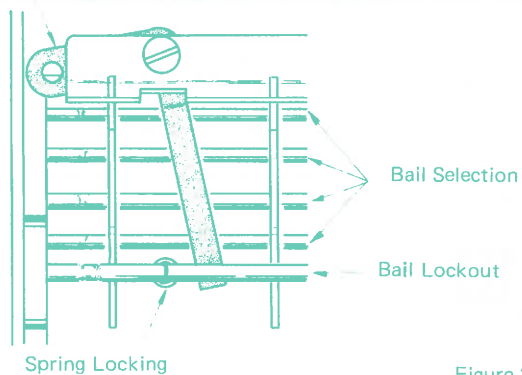
Figure 2

On the 9XX machines the damper spring is mounted at an angle to prevent interference with the locking interposer spring (09-130) (See Figure 2).

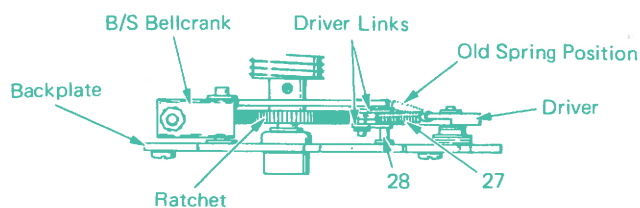
PURPOSE: To eliminate excessive wear and chipping of the ratchet teeth (24-6) due to incorrect alignment of the driver (24-32).

ADJUSTMENTS: Ensure driver to ratchet clearance is .030"-.040" (F/N 241-5939). Lubricate with thin film of No. 23 grease on the backplate where the stud contacts.

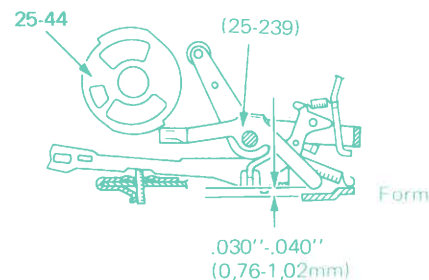
Figure 1

If experiencing a repeating spacebar and backspace operation, check the adjustment shown in Figure 1. Insufficient bite of the clutch release arm (25-239) to the clutch wheel (25-44) can cause early wear. A repeating operational cam may look like escapement failures (skipping or crowding of characters). Check the latching surface on the clutch wheel; if the latch is rounded, the operational cam or the clutch wheel should be changed.

Clutch Release Arm Bite

Note: Check adjustment by manually releasing the latch from the bottom of the machine. Do not check this adjustment by releasing the spacebar as the load of the spacebar interposer will cause an incorrect reading.

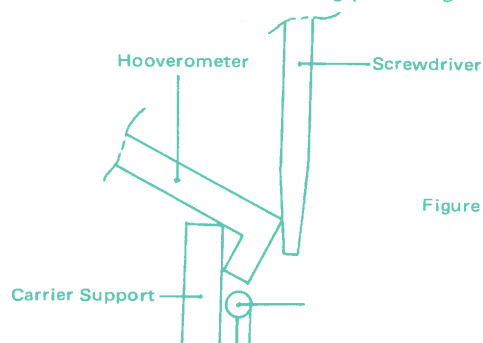
1. Correcting Mechanism is not field installable.
2. 2 additional holes in Cardholder can be cause of paper folding when paper is put in machine with carrier close to LH or RH side of paper. If customer is complaining about this failure, *countersink* (look at figure 1) from rear side both small holes with a metal drill cardholder will be changed.

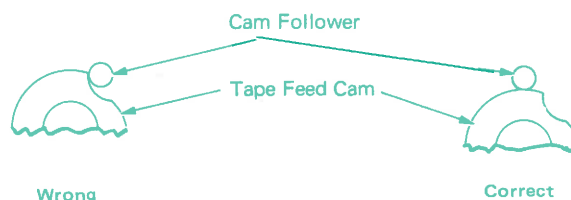
Figure 3

11. Carrier binds in tab or spacebar operations can be caused by tape feed cam follower positioned just off high point of feed cam (look at figure 3). Cam follower position should be adjusted with machine at rest & print shaft play removed backwards. Binds are caused by pressure on right end of print sleeve key against keyway. Check adjustment of rotate homing & timing (Pictorial Ref./ Adj. Manual Form No. 241-5307 to fix this problem.

Note: Gear train backlash & cycle clutch overthrow should be correct.

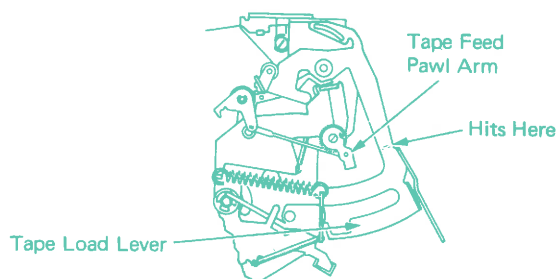
Figure 4

12. If correcting mechanism failures occur check adjustment of tape feed cam follower front lug in Pictorial Ref./Adj. Manual. Make this adjustment with machine at rest & print shaft play removed backwards. If this adjustment is not correct, it can cause bind between feed cam follower (726-45) & feed cam inhibitor (726-53) which prevents correct function.
13. If wrong character has not been removed after correcting mechanism operation, check if tape feed cam inhibitor (726-53) works. Cam follower should not be on tape feed cam when type-head is moved towards platen.
14. Intermittent correcting tape feed failures can be caused if tape load lever (726-15) hits tape feed pawl arm (726-4). Form tape load lever if you have this problem (look at figure 4).

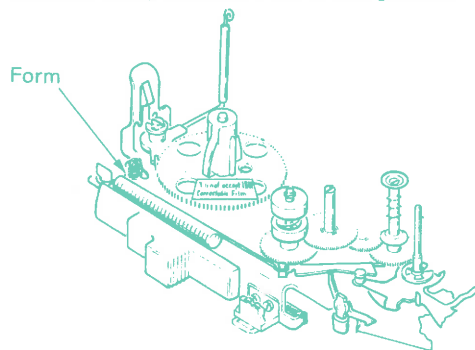
Figure 1

Folding condition occurs as ribbon enters take up side of cartridge when ribbon is installed or re-installed. If ribbon starts to fold it will not tape-up correctly.

1. Cartridge should be checked before installing to see that ribbon leader is centered on ribbon & on supply *core*. If not, it will cause binds in cartridge.
2. Check shock arm wire (715-83) does not contact supply spool teeth when ribbon is in load position.
3. Adjust left cartridge retainer clip as far left as possible.
4. Form front cartridge support lug for clearance of 0,25 - 0,38 mm (.010"-.015") between cartridge & lug (Figure 1).
5. Check that take up *core* interlock prevents cartridge from being turned in wrong direction when in load position.

To prevent this problem, *operators* should be told to turn ribbon only until leader is even with right edge of cardholder. When re-installing ribbon, it should be turned only until loose ribbon is taken up. If more movement is needed, it should be done by typing.

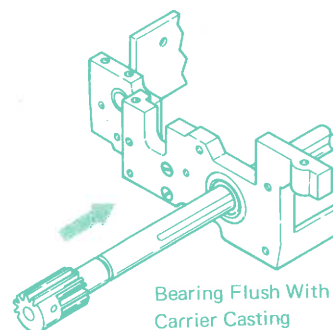
Figure 1

Remove left-hand wiper retainer (702-48) and wiper (702-50); check left-hand carrier bearing. Bearing should be flush with carrier *casting*. If bearing extends out of the *casting*, it is possible for the lift cam follower to slip off the lift cam. Use following procedure to correct this condition:

1. Move carrier to the center of the machine.
2. Remove print shaft gear (702-40) and retainer (702-51). Slide the print shaft to the right until it clears the left side of power frame, then remove wiper and retainer; reinstall print shaft gear and tighten both screws (702-41).
3. Loosen ribbon lift cam screw (726-112) and Print Cam Screw (702-203).
4. Use print shaft gear to drive bearing into carrier casting by sliding print shaft to the right. Repeat this until the bearing is driven flush with left side of carrier casting.

Caution: Do not apply too much force so as to drive the bearing too far (Figure 1).

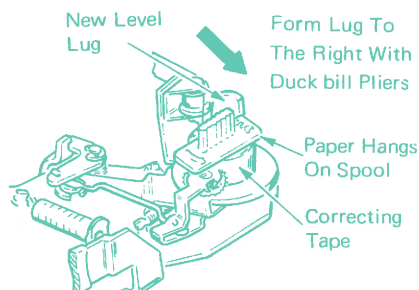
Figure 1

SOLUTION: If experiencing problems with the correcting tape take up spool interfering with the top edge of cards or forms, the new level lug (Figure 1) can be formed to the right. This keeps the paper from hitting the upper flange of the take up spool. Also, it may be necessary to readjust the lug front-to-rear for clearance to the platen according to frame 307 (APM 241-5939).

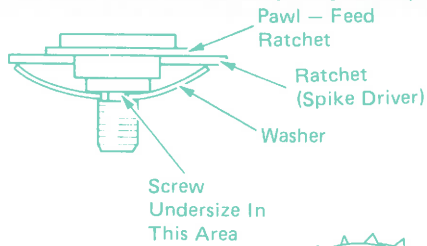
Figure 1

SYMPTOM: Intermittent correction tape feed failures and/or incomplete lift off may be caused by a defective pawl feed mounting screw (26-5). The screw is undersize in the area where the washer (26-7) is mounted (Figure 1). This allows the washer to be off center and partially cover the teeth on the spiked take-up ratchet (Figure 2).

SOLUTION: When experiencing this problem, replace the screw (26-5).
